**LABORATORY PERFORMANCE TESTS
ON A MECHANICALLY FASTENED STONE VENEER PANEL - VENA**

Prepared for: **LES PIERRES ROYALES INC.**
1041 Bd Lionel-Boulet
Varenes, QC J3X 1P7

Report no.: AS-01644

Date: March 8th, 2023

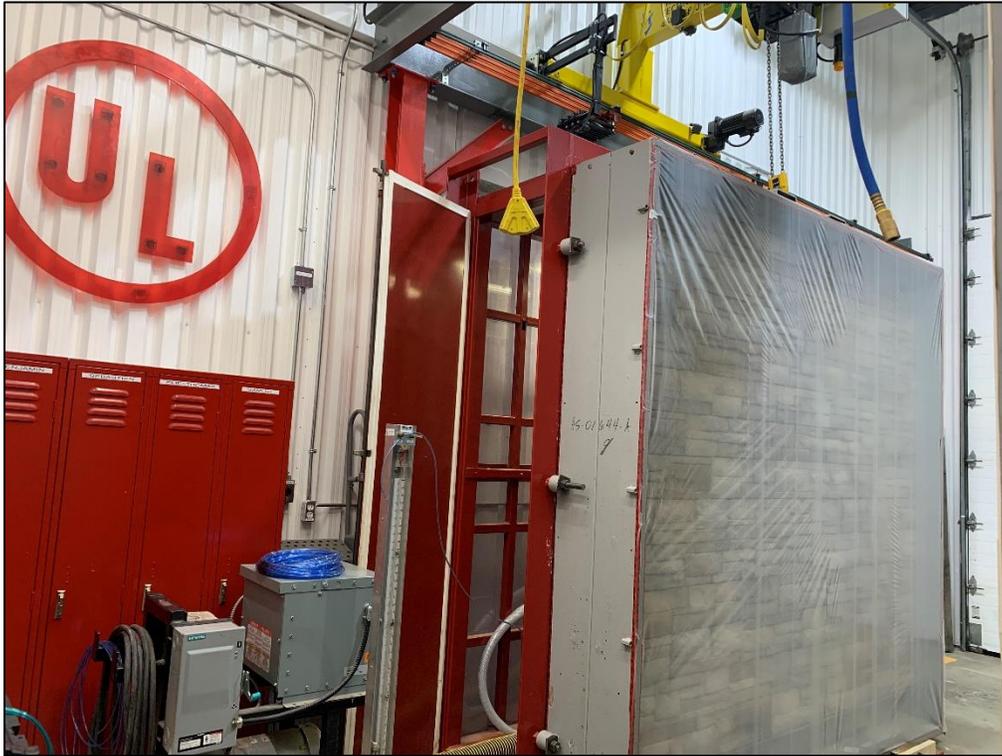
C-01 Air Leakage Test

The air leakage rate of the prototype, for both positive and negative cases, was determined at a pressure differential of 75 Pa.

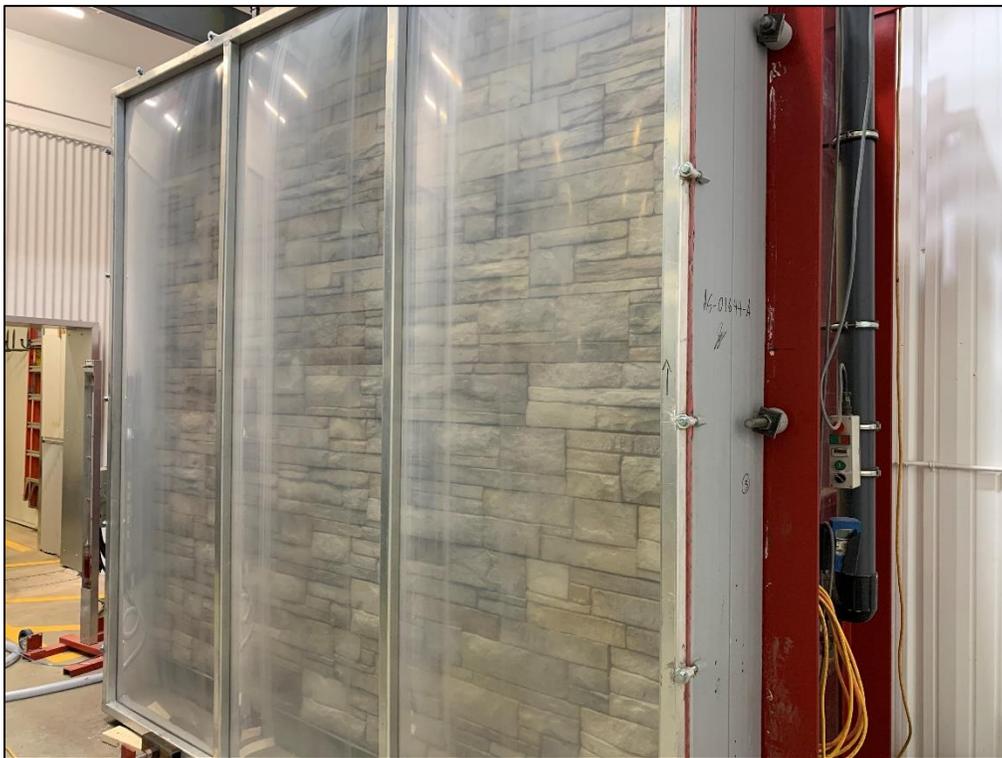
C-02 Taking leak measurements from the test bench during airtightness tests

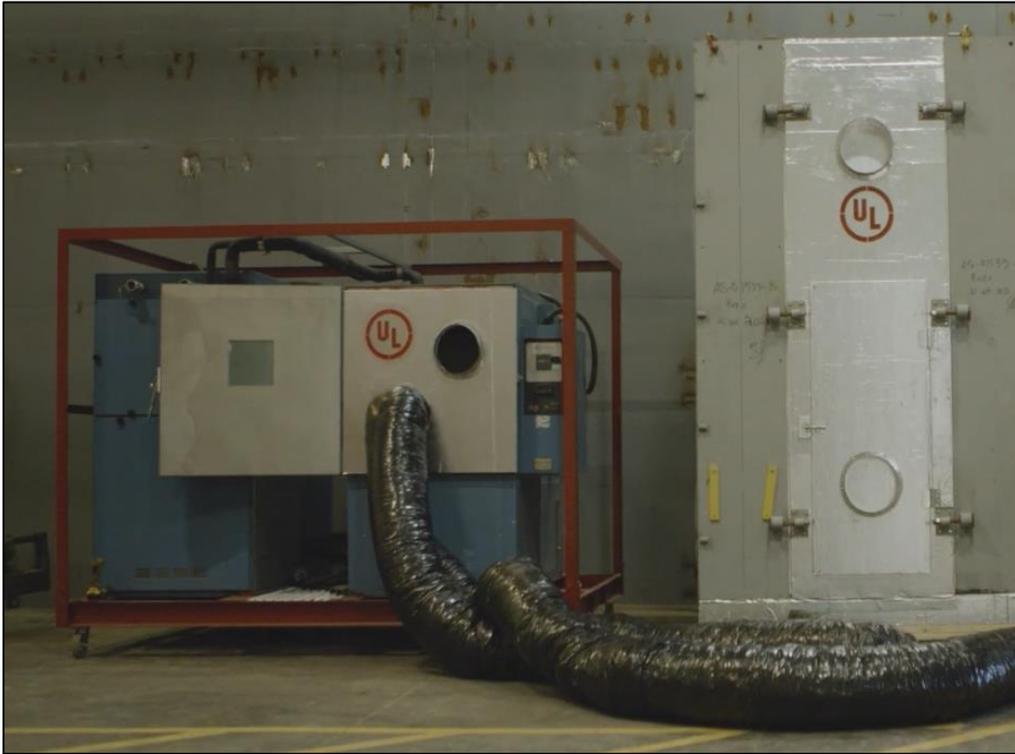
C-03 Test bench for extreme thermal conditioning and freeze/thaw

The freeze-thaw conditioning test consists of subjecting the prototype to 50 cycles of temperature variation lasting 8 hours each. A freeze-thaw cycle takes place as follows: one hour at 24°C with exposure to water, one hour transition to lower the temperature to -10°C, two hours at a maintained temperature of -10° C, one hour transition to increase the temperature to 70°C, two hours at a maintained temperature of 60°C, one hour transition to decrease the temperature to 24°C.

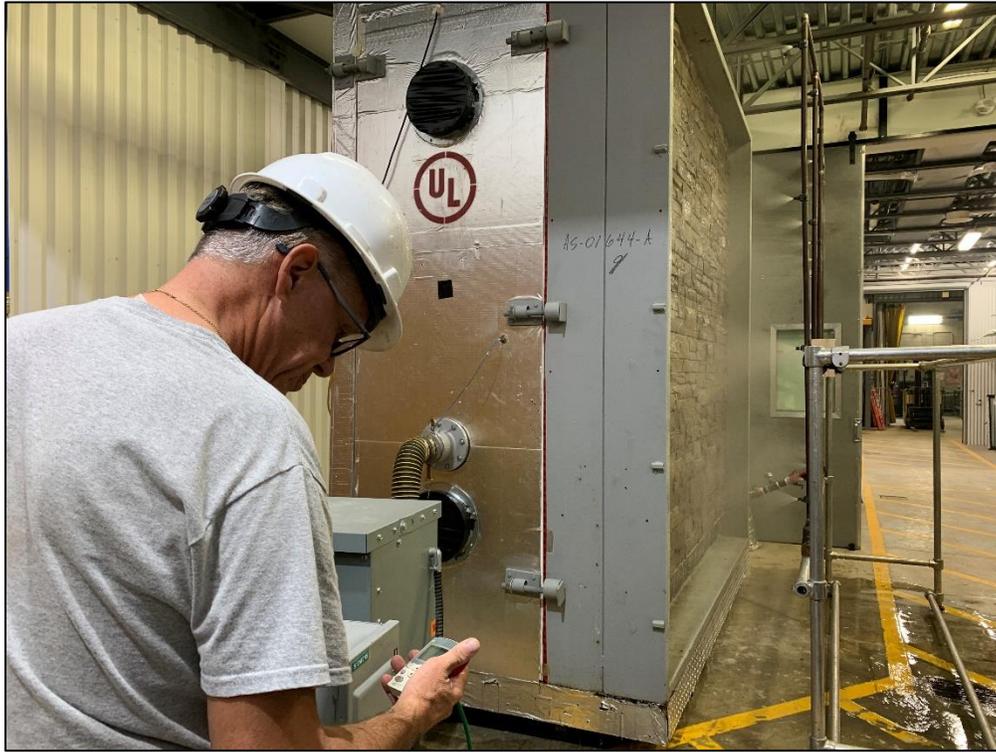
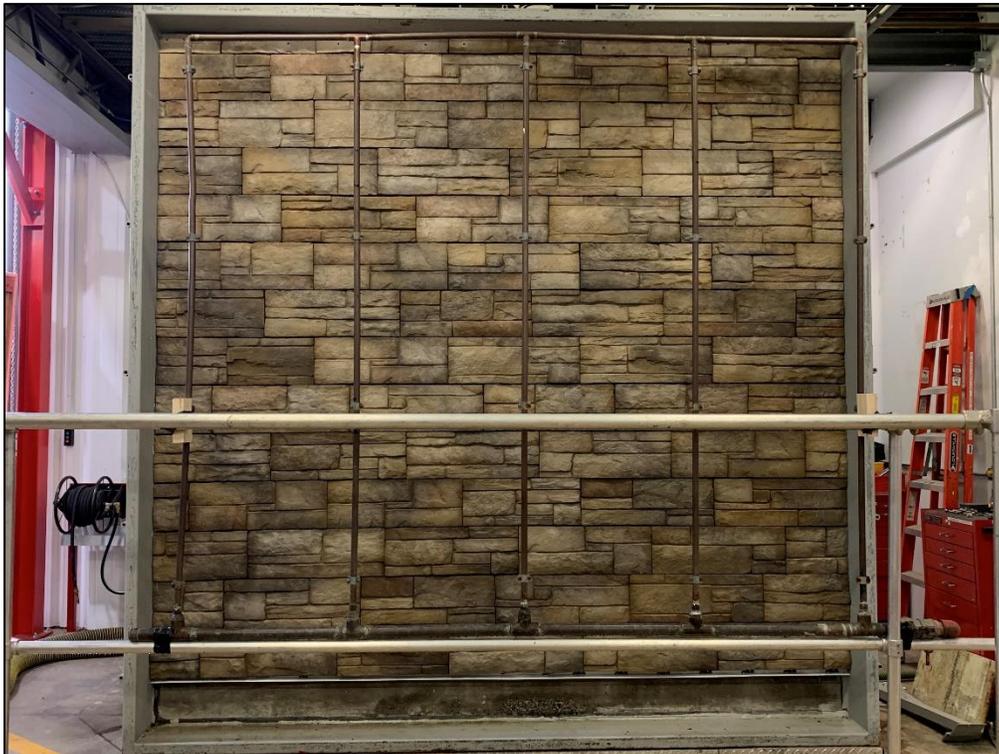
C-05 Water Resistance Penetration Test Under Static Pressure

C-06 Water Resistance Penetration Test Under Static Pressure

C-10 Water Resistance Penetration Test Under Static Pressure

The static water penetration test was conducted as per *ASTM E331* under static pressure differential of 720 Pa. Pressure was maintained for a period of 15 minutes. The prototype was subjected to a uniform water spray of 3.4 L/min·m² (5 U.S. gal/ ft²-hour) during the entire static water penetration test.

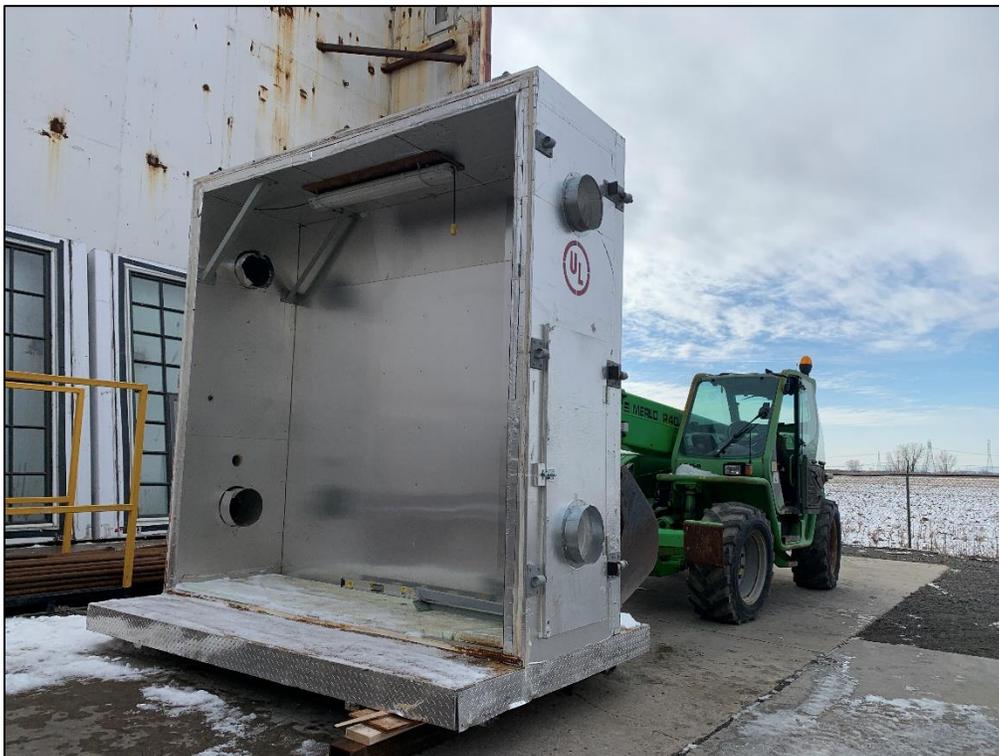
C-08 Preparation of the dynamic test bench

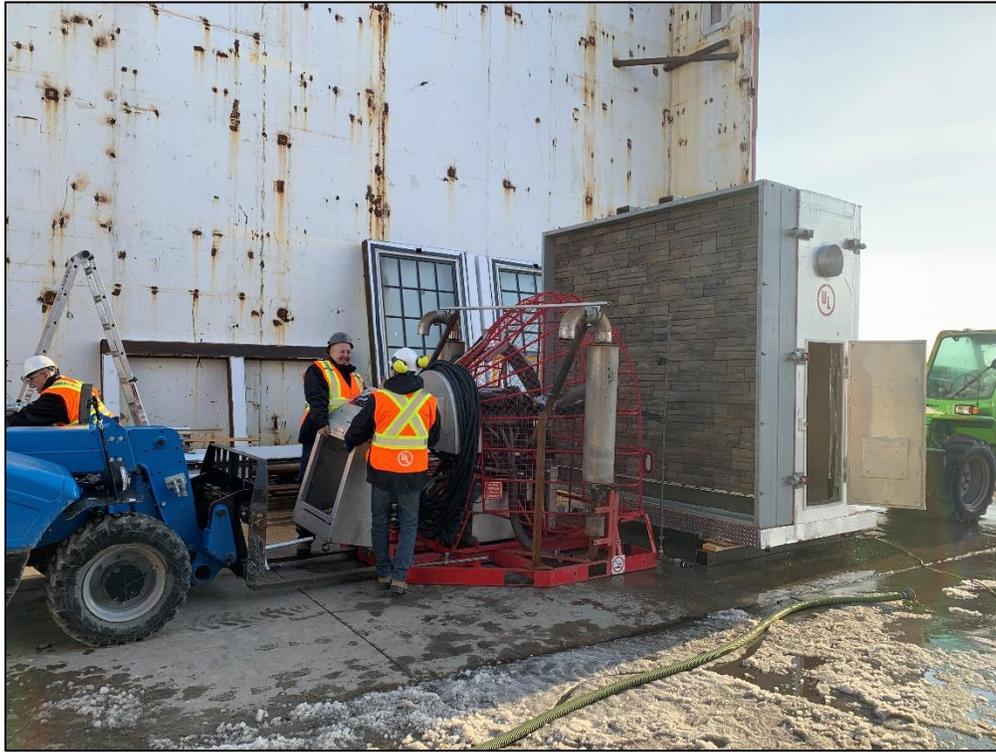
C-09 Mobilization for rain resistance test under dynamic pressure

The dynamic water penetration test was conducted as per *AAMA 501.1* under a dynamic pressure differential of 720 Pa maintained for a time period of 15 minutes. The prototype was subjected to a uniform water spray of 3.4 L/min·m² (5 U.S. gal/ ft²·hour) during the entire static water penetration test.
